National Park Service Jefferson National Expansion Memorial Gateway Arch

St. Louis, Missouri

Historic Structure Report – Volume 1

June 2010

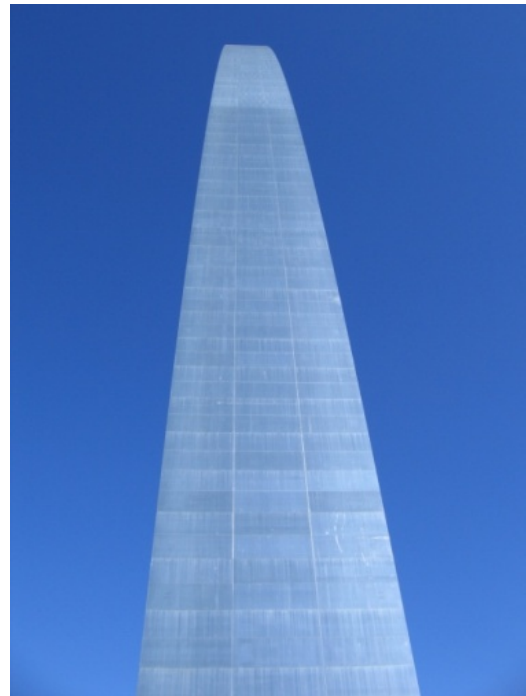
On the east and west faces of the Gateway Arch, the staining is more severe. The majority of the staining is rust-colored and appears at levels above the 300 foot concrete fill. From these observations, it is hypothesized that corrosion has initiated at a contaminated or damaged surface. The west faces of both the north leg and the south leg were viewed from the dome of the Old Courthouse and from the ground (Figure 36). The east face of both legs was viewed from the ground (Figures 34 through 39).

Figure 35. Overview of the south face of the south leg. A change in coloration is discernible at the 300 foot level near the top of the image. Source: WJE, 2008.

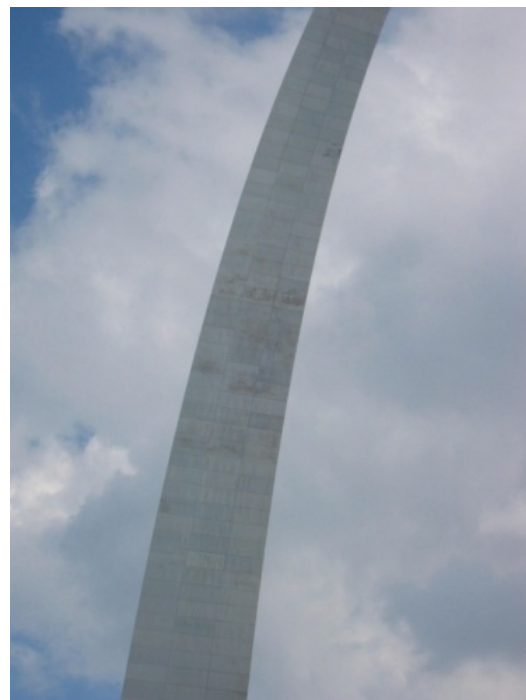
Figure 36. Overview of the west face of the north leg. Source: WJE, 2008.

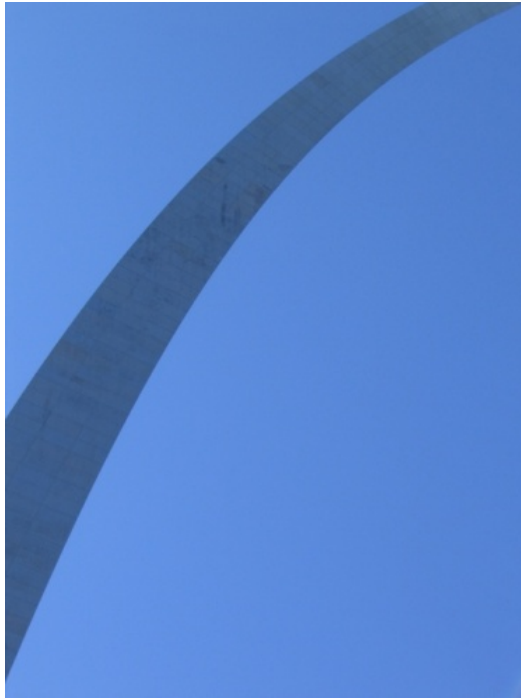
*Figure 37. Overview of the east face of the south leg.
Source: WJE, 2008.*

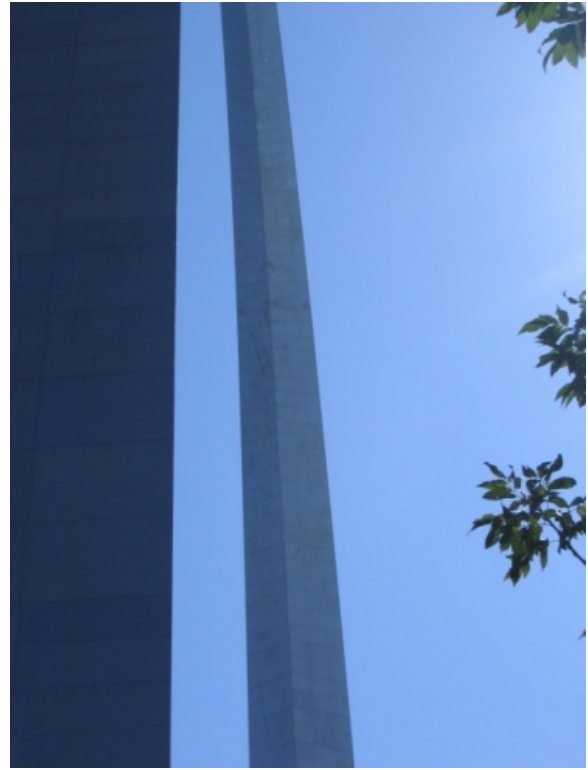
*Figure 39. View of the south leg seen from grade,
with the north leg in the foreground. Source: WJE,
2008.*

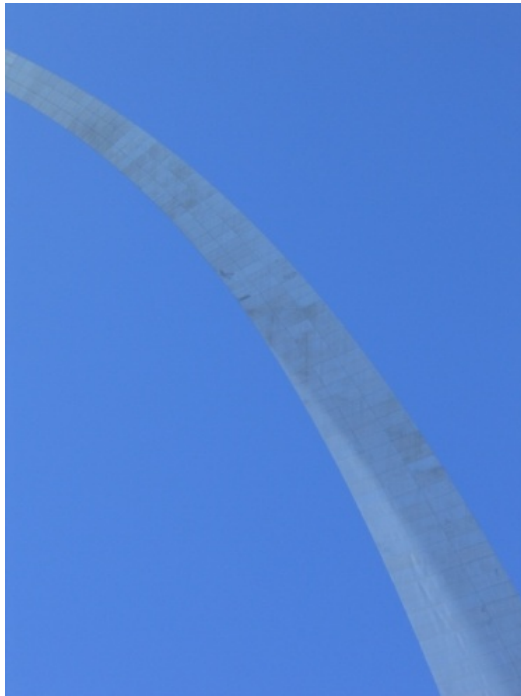
*Figure 38. Overview of the east face of the north leg.
Source: WJE, 2008.*

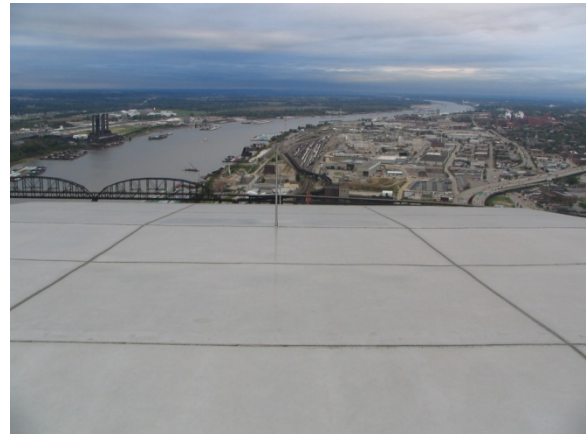
The stainless steel skin on the topside of the structure was inspected from the roof hatch. The stainless steel appears to be in good condition. Figures 40 and 41 show the stainless steel panels and welds from the roof hatch.

*Figure 40. View looking south from the roof hatch at
the top of the Arch. Source: WJE, 2008.*

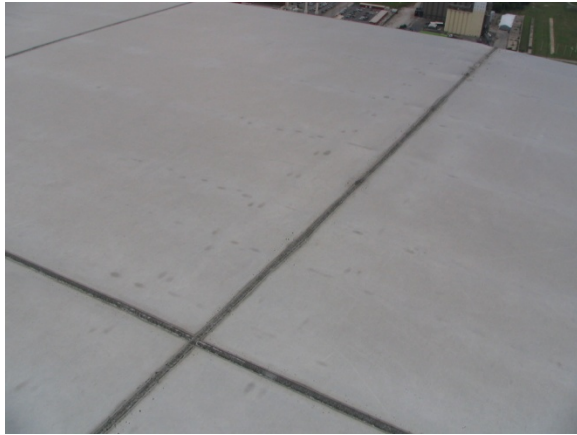
Figure 41. Closer view of stainless steel panels and welds at the roof hatch at the top of the Arch. Source: WJE, 2008.

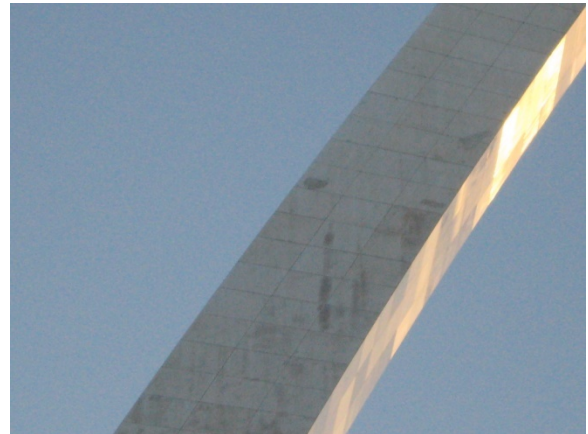
Streaking, caused by the field welds, is obvious on the north and south faces. The field welds are not ground flush, thus have more roughness that collects atmospheric soiling that washes out when water runs over the welds, causing streaking below (Figures 42 and 43). Streaking caused by the field welds is also detectable on the east and west faces (Figure 44). Due to the curved shape of the Arch, the streaking on the east and west faces often flows diagonally to the grid pattern of the stainless steel panels.

Figure 43. Dark staining on the east face of the south leg, showing dark staining originating at field welds. Source: WJE, 2008.

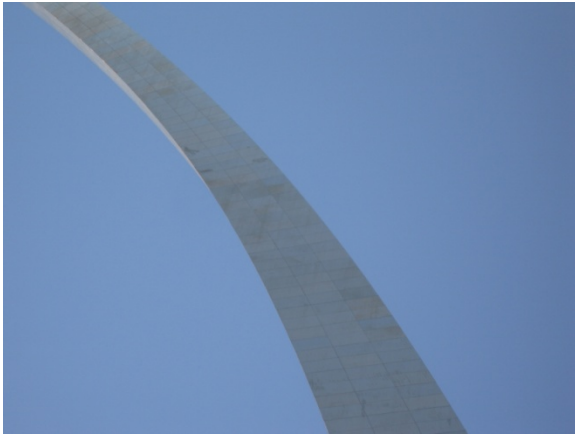
Figure 44. Overview of intermittent staining on the east face of the north leg. Source: WJE, 2008.

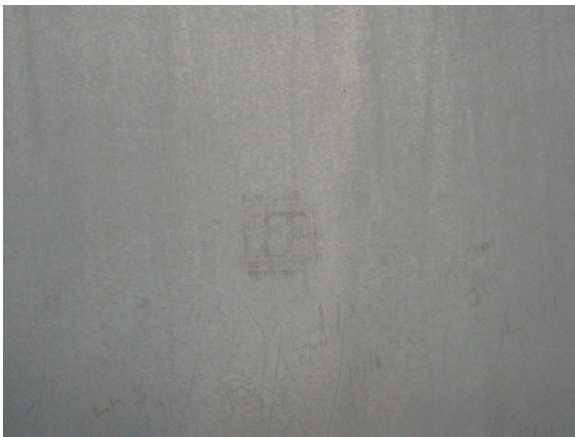
Locations of bearing pads beneath creeper derrick rails are visible. The pads may have polished or abraded the surface of the stainless steel panels, leaving lasting marks (Figure 45).

Figure 45. Detail showing mark on Arch surface at the location of an original derrick creeper crane bearing pad. Source: WJE, 2008.

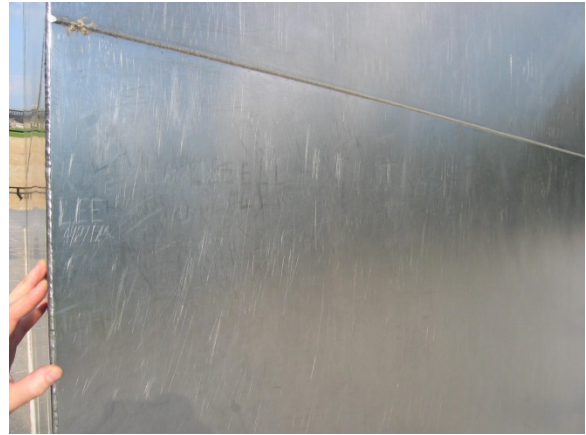
Approximately the lower fifteen feet of exterior surface at the base of each leg have superficial brown staining and mechanical surface damage. The surface has been damaged by graffiti and gouging in the steel with sharp tools, hammers, drills, etc. Also, previous abrasive cleaning techniques used to remove graffiti may have contributed to the existing superficial staining. Some of the corrosion at the base can be attributed to the presence of de-icing salts. Park maintenance staff described the use of salts during winter months around the base of the Arch and along entry routes to the Arch visitor center. Given the recent installation of a snow-melt system and new paving around the base of each leg, it would be expected that further use of de-icing salts will be limited. Additionally, some panels above the base level are also corroded where de-icing salts would usually not be present. See Figures 46 through 49 for representative examples of the steel condition at the base of each leg.

Figure 46. Graffiti damage at the base of the Arch. Source: WJE, 2008.

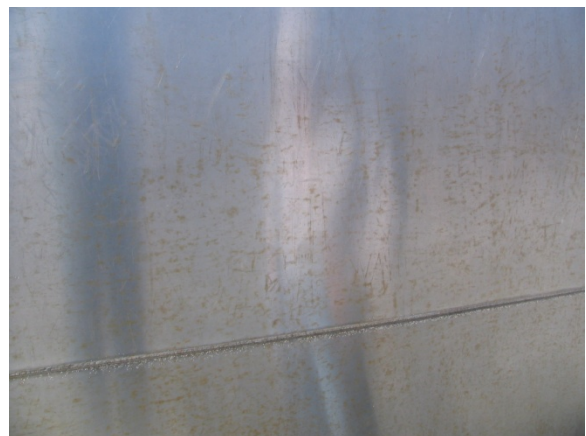
Figure 48. Detail of brown staining near the base of the Arch, which forms at the locations of scratches or other mechanical damage. Source: WJE, 2008.

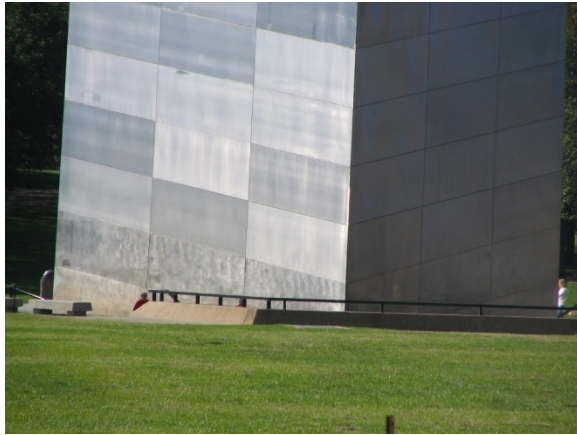
Figure 49. Periodic cleaning to remove graffiti is changing the finished surface of the panels near the base of the leg. Source: WJE, 2008.

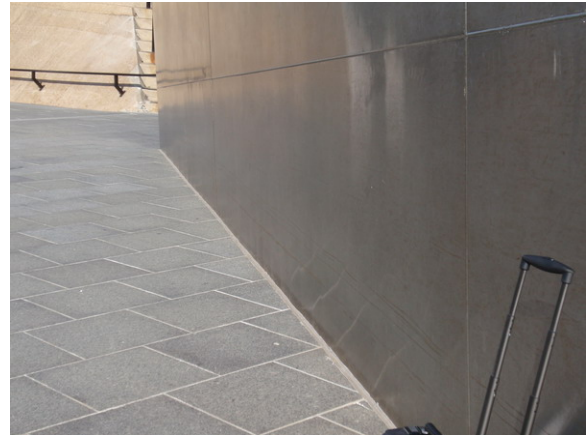
corrosion product when “the environment overwhelms the stainless steel’s passive film and it cannot heal the interruption.”¹⁰² As a result, in crevices and pits a red oxidation product may form as was observed on the Gateway Arch at the incised graffiti. Ferrous deposits from the snow-removal equipment or the implements used to create the incised graffiti may also be contributing to the red corrosion stains. The presence of aerosol chlorides from deicing salts may also have contributed the pitting corrosion of the stainless steel. The newly-installed snow-melt system is expected to limit future use of deicing salts. Atmospheric contaminants and pollutants may also contribute to surface corrosion of the stainless steel.

Figure 52. Red-colored staining and scratches near grade, possibly associated with past use of steel snow-removal equipment. Source: WJE, 2008.

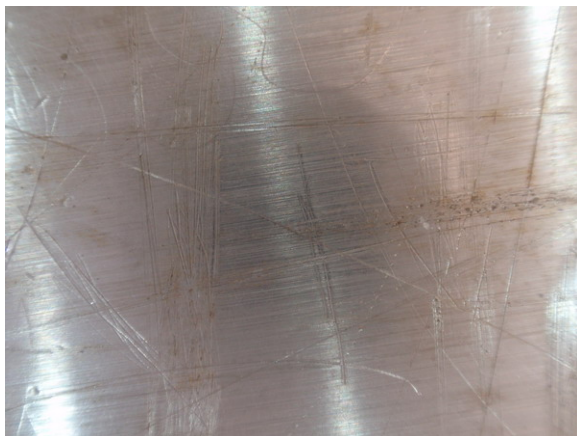
The lowest two sections near the grade of the arch exhibit incised graffiti and corrosion staining. The incised graffiti ranges in condition from shallow scratching (Figure 50) to deep scratching. At some locations there is red corrosion associated with the scratches (Figure 51), as further discussed below. In addition, horizontal corrosion stain lines were observed near the base that may be related to the possible use of steel shovels or plows used to remove snow from the plaza in the winter (Figure 52). The plaza has a recently installed snow melt system, and the future use of metal shovels will be limited. At some locations near the base there are also light red corrosion stains (Figure 53).

Figure 50. Scratches and incised graffiti on the Arch. Source: WJE, 2008.

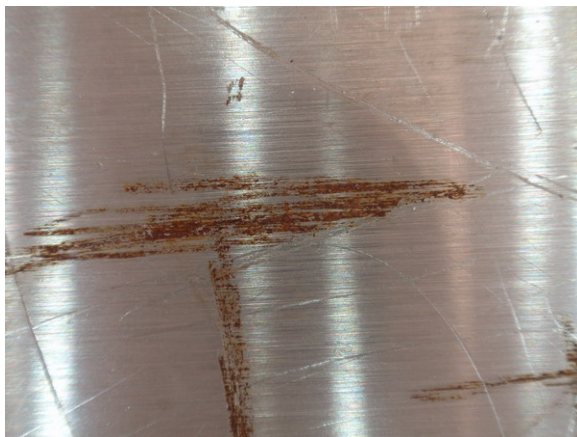
Figure 51 Red-colored corrosion associated with scratches. Source: WJE, 2008.

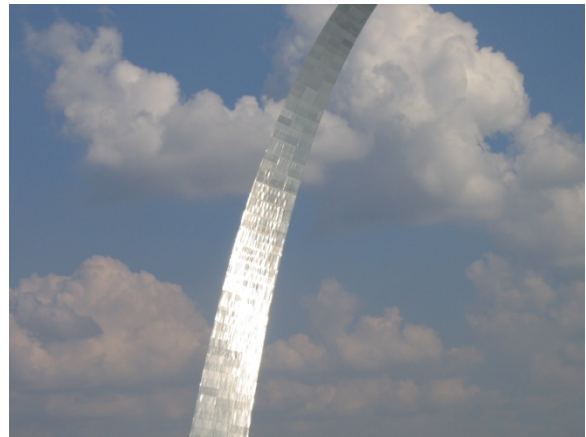
Visual distortion of the surface of the Arch is more visible above the concrete infill, which is consistent with conditions documented in archival photographs (Figures 54 through 56). One apparent phenomenon on the Arch is “oil canning,” which refers to the tendency of flat sheets of metal to undulate in and out of plane. The lack of optical flatness is more apparent on reflective surfaces and appears as a slight darkening and waviness. Oil canning is visually prominent above the 300 foot level where the stainless steel is reinforced on the inside with steel stiffeners. Below the 300 foot level, where concrete was introduced into the interstitial space, minimal oil canning is apparent. This phenomenon was apparent soon after the Arch was completed, according to Mr. Kolkmeier.¹⁰³

Figure 55. View of oil canning on the west face of the north leg. Source: WJE, 2008.

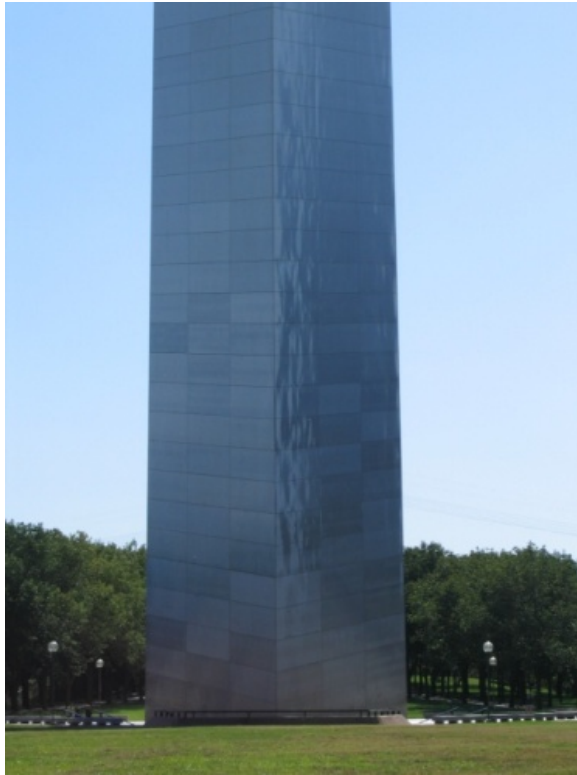
Figure 56. View of oil canning on the east and west faces of the south leg near grade. Source: WJE, 2008.

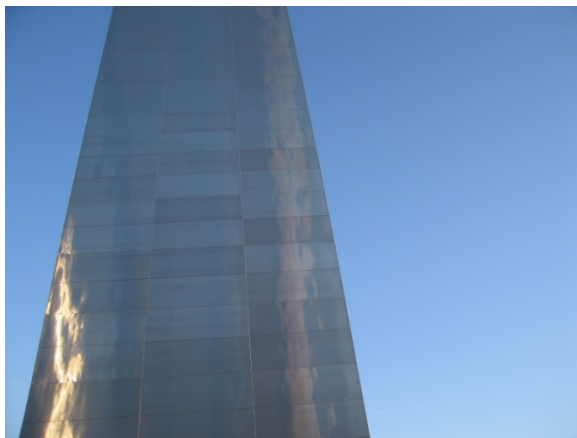
The variations in surface plane (waviness) of the exterior plates is less visible on the north and south faces of the legs, as compared with the east and west, because of the specific geometries at these locations. The plate buckling characteristics are visible on the north and south faces in certain lights (Figures 57 and 58). Regarding the wrinkles in the exterior plates, Mr. Kolkmeier noted that Section 46 on the north leg buckled slightly as it was being worked into place, and that PDM dismantled and reworked the steel plates in this area. He also mentioned that “anyone who expected that it [the 1/4 inch stainless steel panels] would have no wrinkles did not have a very good instruction in strength of material because when you weld on the back side of 1/4 inch material you get distortion from the welding.”¹⁰⁴ Mr. Kolkmeier also noted that structural engineer Hannskarl Bandel helped develop the solution implemented at Section 46; holes were cut in the top of

Figure 57. Surface waviness on the outside face of the Arch leg. Source: WJE, 2008.

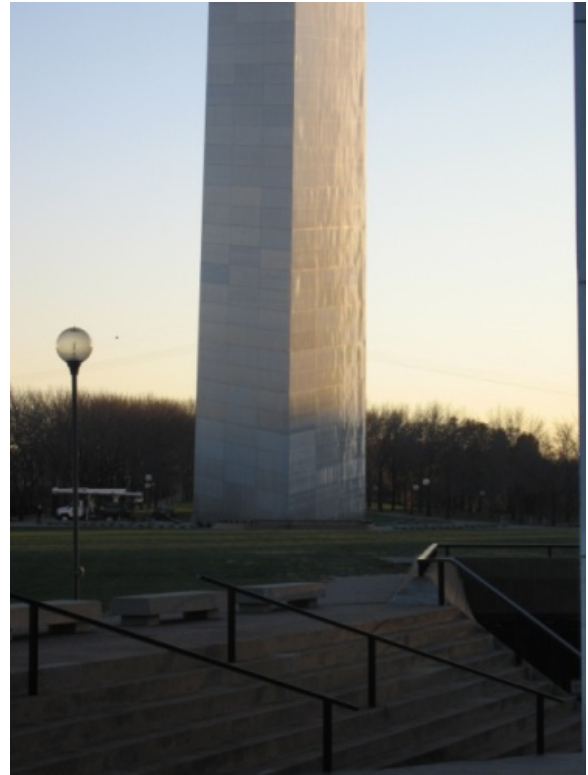
Figure 58. Surface waviness on the west face of the south leg, visible in late afternoon sunlight. Source: WJE, 2008.

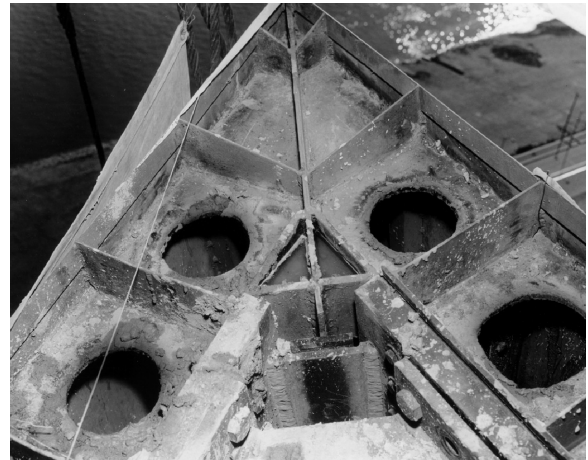
Figure 59. View of the continuous transverse plates added to Segment 46. Photograph courtesy of Ken Kolkmeier.

the continuous transverse plates and the section was filled with concrete, as shown in Figure 59. At the south leg Section 46 was also filled with concrete to provide symmetry. The outlines of the vertical stiffener angles are visible above and below the level of the concrete fill (Figure 60).

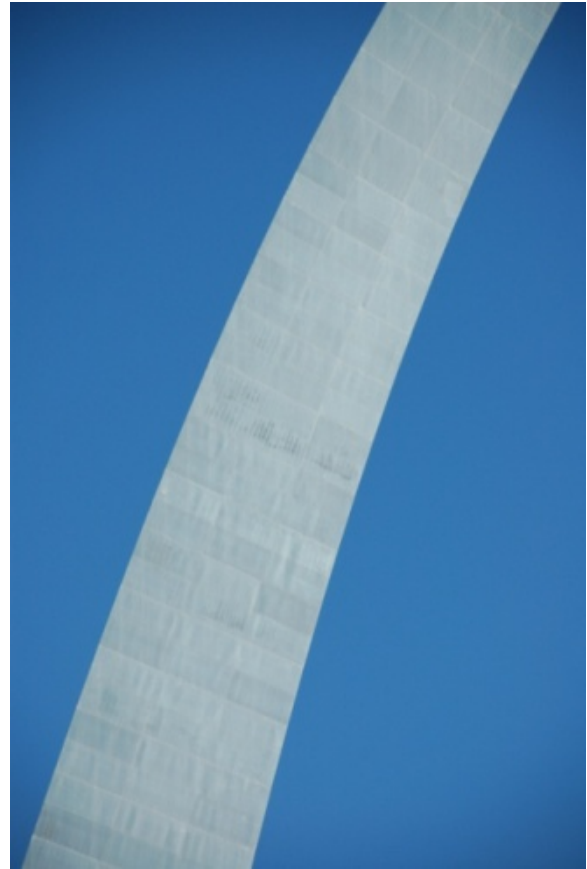
Figure 60. View of the north leg at the 300 foot level. Source: WJE, 2008.

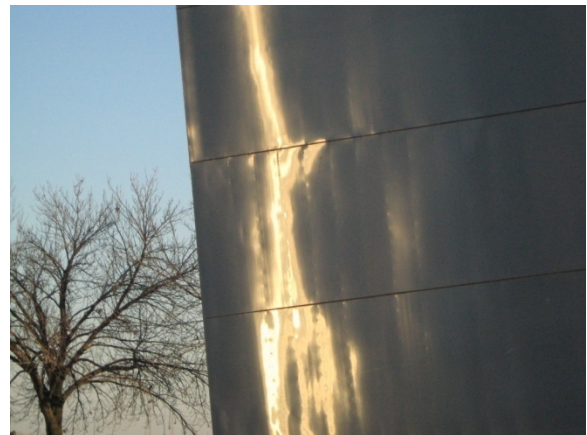
Stitch welds of vertical stiffener angles below the level of the concrete fill are slightly visible on the exterior skin in certain lights (Figures 61 through 63). Stitch welds of vertical stiffener angles above the level of the concrete fill are more significantly visible on surface of the exterior skin.

Figure 61. Vertical lines corresponding to stiffener angles are visible near grade. Source: WJE, 2008.

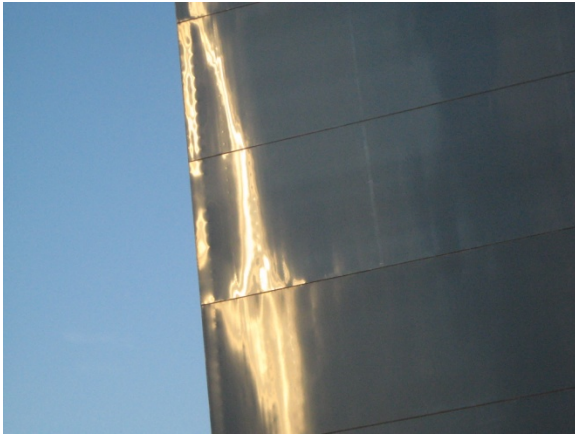
Figure 62. Vertical lines corresponding to stiffener angles are visible below the 300 foot level. Source: WJE, 2008.

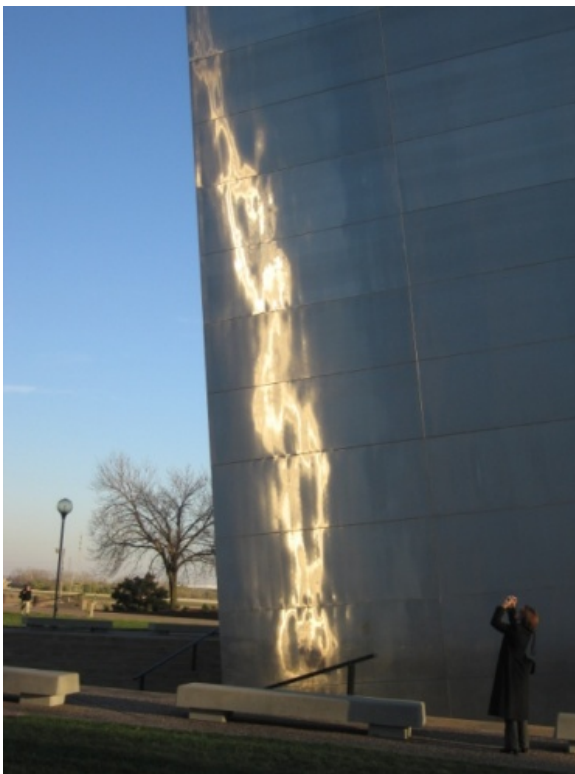
Figure 63. Vertical lines corresponding to stiffener angles are visible near grade on the west face of the south leg. Source: WJE, 2008.

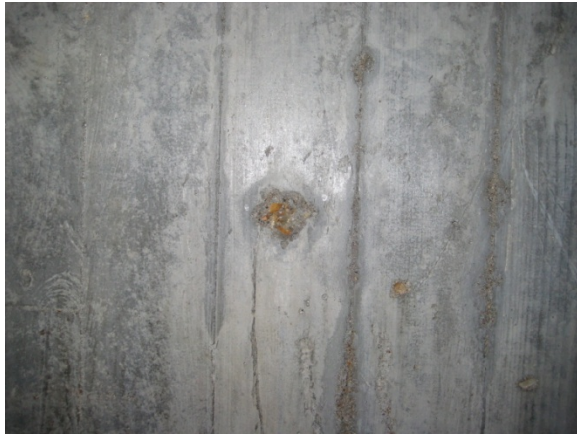
Figure 64. Example of concrete wall surface spalling in the lower tram load zones. Source: BVH, 2008.

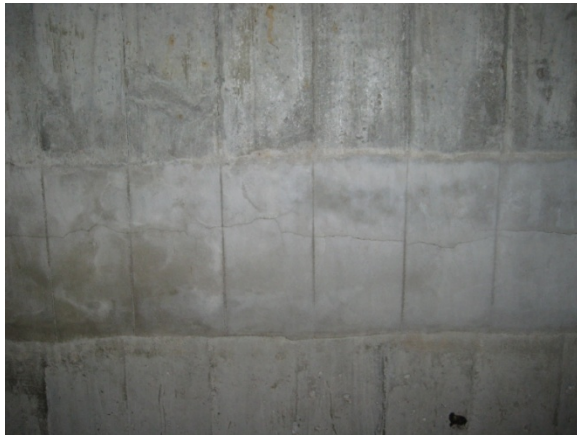
Figure 65. Demarcation of concrete pour lifts in lower tram load zones. Note the hairline cracking at cold joint between lifts. Source: BVH, 2008.

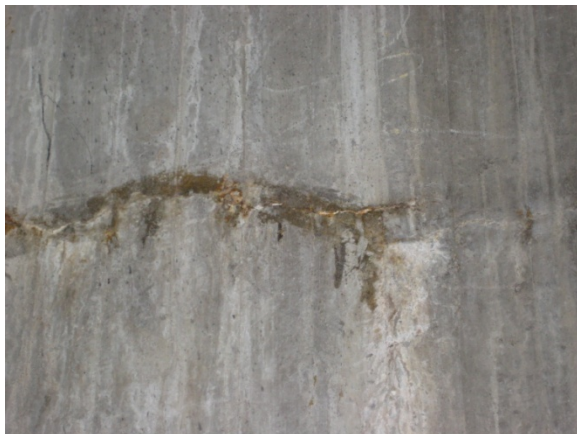
Figure 66. Hairline crack in concrete wall. Note previous attempt at patching. Source: BVH, 2008.

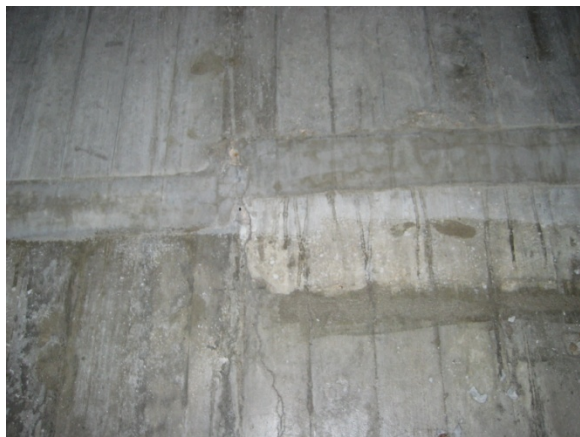
Figure 67. Example of previous repair attempts of cracks in concrete walls. Source: BVH, 2008.

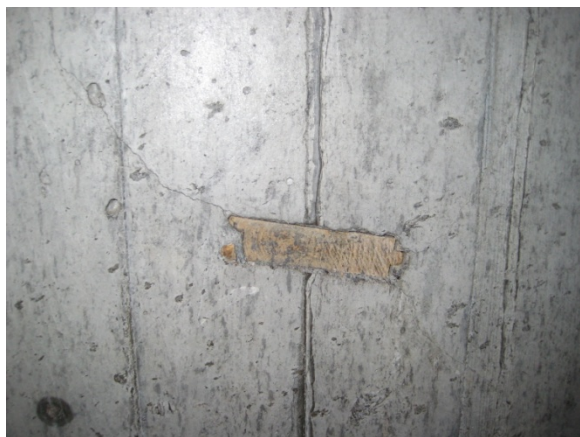
The walls of the north and south tram load zones consist of exposed grey concrete with vertical form board markings. Vertical board formwork was used extensively, especially in the original construction of the subterranean portions of the Gateway Arch. The graining and knot defects of the formwork are translated to the exposed concrete walls, providing subtle texture to the walls. The walls of the tram load zones are generally of a smooth finish with sporadic indication of voids and honeycombing where air pockets formed during the pours. The walls exhibit minor spalling and chipping of the surface paste, revealing the aggregate beneath (Figure 64). The lift pours of the concrete walls are evident and occur approximately every 10 feet vertically. The seams of the pour lifts have been troweled over with a cementitious patching material, and vertical grooves cut to continue the vertical formboard markings of the walls. The horizontal line of the lift demarcations is flush with the rest of the wall surface; however, the patch material is of a different coloration and texture, creating a banding effect (Figure 65). Horizontal cracks have developed at the seams of the pour lifts, most likely indicating a cold joint that has telegraphed through the cementitious patching. Minor cracks have developed in the concrete walls, possibly due to shrinkage of the concrete. These cracks range in size from hairline to approximately 1/16 inch in width (Figures 66 and 67). At isolated locations, foreign objects can be seen embedded in the concrete wall; a tongue-and-groove-wood slat is embedded in the concrete wall as shown in Figure 68.

Figure 68. Tongue-and-groove wood slat embedded in concrete wall. Source: BVH, 2008.

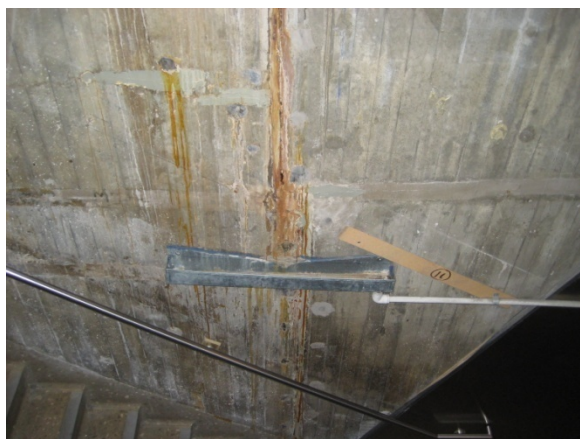
While generally in fair condition, the walls show signs of moderate to severe deterioration in a few locations. Indications of water infiltration in certain areas have caused severe staining to the concrete walls. These areas are near expansion joints and wall-to-ceiling interfaces. The most extensive water infiltration occurs at the west wall of the stairs in the north leg of the Arch that lead down to the lower tram load zone. The area of leakage occurs at the location of an expansion joint in the subterranean concrete wall. This leakage is occurring at an active breach that is allowing water to infiltrate on a regular basis. A galvanized steel gutter has been affixed to the wall to collect and shunt the active flow to a drain. Polyvinyl chloride (PVC) piping connects the galvanized gutter to a garden hose that penetrates through the concrete wall at a drilled hole approximately 2 inches in diameter (Figures 69 and 70). Previous attempts to mitigate the leakage at this location are evident. There are indications of water infiltration at the expansion joint in the east subterranean concrete wall near the stair landing leading down to the tram load zone in the south leg of the Arch. The leakage has severely discolored the concrete wall along the edges of the expansion joint (Figure 71). The probable cause of both instances of leakage at the expansion joints is the proximity of the expansion joints to the trench drains located in the ramp leading down to the main exterior entrance to the Arch (Figure 72).

Figure 69. Galvanized gutter installed to collect water infiltration at expansion joint in north tram load zone. Note the staining and previous attempts at repairs. Source: BVH, 2008.

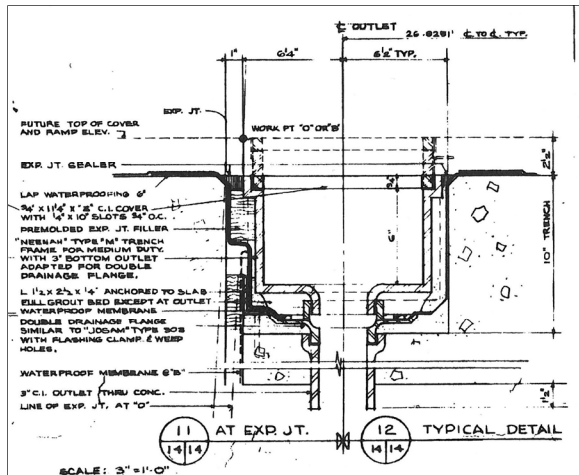
Figure 72. Original construction detail of trench drain located in entry ramps. Note proximity of expansion joint to trench drain. Source: Original Saarinen Construction Documents, detail 11, sheet A14, 1961, JNEM archives, digitized as part of HSR project.

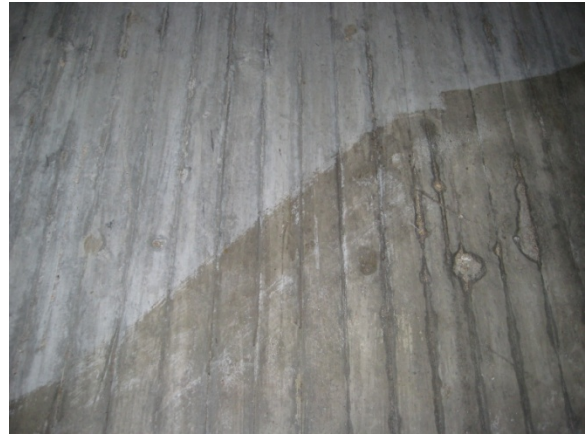
The walls in both the north and south legs of the Arch have been sealed with a concrete sealer. This observation was corroborated by JNEM staff. The concrete sealer extends up the walls approximately eight feet above the walking surfaces. The concrete sealer was rolled on with a paint roller and has altered the color of the grey concrete wall, making it darker in appearance than that of the unsealed concrete above (Figure 74). The sealer was reportedly applied by JNEM staff to keep oils from visitors' hands from staining the concrete near handrails and other locations that visitors are likely to touch. Specification information regarding the concrete sealer used was unavailable and therefore the type of sealer applied is not known at this time. Further material research may be required to determine the type of sealer used and date of application.

Figure 74. Concrete sealer applied to concrete walls. Source: BVH, 2008.

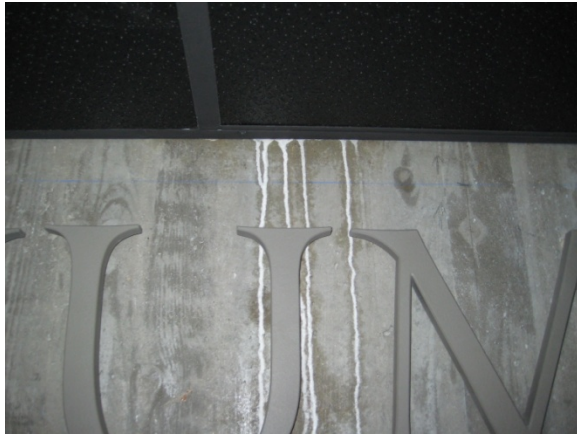
Staining of the concrete walls was noted at other isolated locations. In the south leg of the Arch on the east wall of the upper exhibit area, streaking of a bituminous/asphaltic material extends down the wall from the ceiling plane approximately 4 feet (Figure 75). Another area of streaking was observed in the north leg of the Arch, on the east wall of the upper exhibit area. This streaking is white in color and extends down from the ceiling plane approximately 3 feet (Figure 76).

Figure 76. Example of isolated staining in upper exhibit area of the north tram load zone. Source: BVH, 2008.

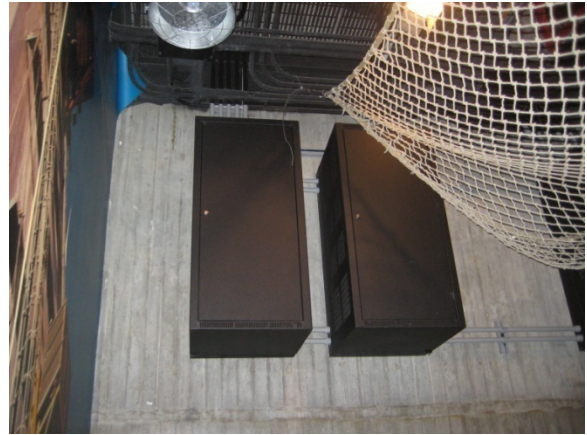
Various appurtenances such as signage and wall murals are affixed to the concrete walls. Interpretive materials cover much of the concrete wall surface in the display areas and tram load zones. The murals are furred out approximately 2 inches from the plane of the concrete wall. The furring is mechanically attached to the concrete walls with screws and anchors drilled into the concrete walls. The interpretive materials are typically printed on canvas or vinyl and adhered to a plywood backing. Conduit has also been mounted on the wall surface and feeds various items such as the fire alarm strobes, electrical equipment, and a sound system that have been added to the spaces over time (Figure 79).

Figure 79. Example of equipment and conduit attached to concrete walls. Source: BVH, 2008.

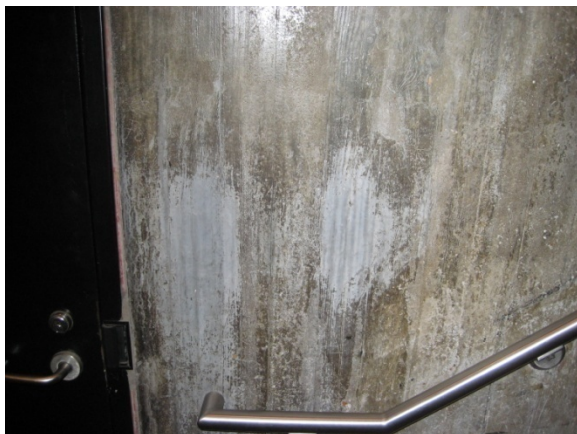
Miscellaneous patches and repairs have been made to the walls as part of previous repair campaigns. These repairs range from brushed repairs with an epoxy-like material (Figure 77) to plugging of drilled holes in the concrete wall where handrails were once attached (Figure 78). Due to a lack of routine maintenance records, it is unclear when and what materials were used in the repairs. Further research may be required to ascertain the nature of these repairs and dates of completion.

Figure 77. Example of previous repair campaigns to concrete walls. Source: BVH, 2008.

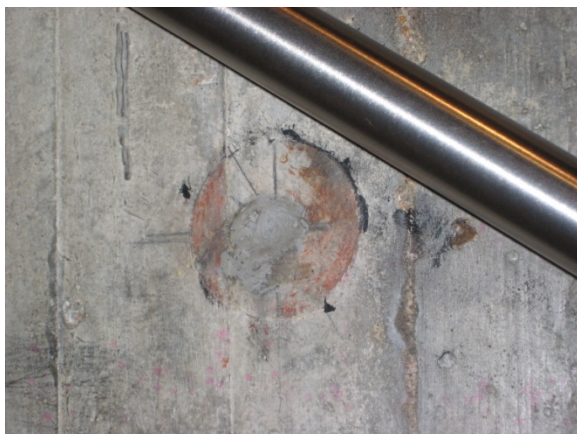
Figure 78. Patching of concrete wall at former handrail location. Source: BVH, 2008.

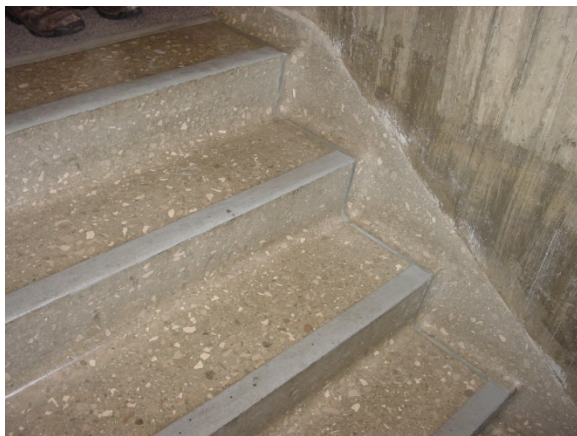
The terrazzo flooring in the tram load zones is generally in very good condition with minor cracks and hairline cracks evident. Minor patching of the terrazzo floor in the lower levels of the tram load zones is also evident where tram queuing railings have changed configuration (Figure 86). The terrazzo patching has been well executed and blends with the rest of the floor surface. The floor to wall transition is a terrazzo base cove that turns up 4 inches and is flush with the concrete walls. Carpet has been laid over the terrazzo flooring in the upper level interpretive and display areas of the tram load zones with adhesive. The carpet is blue-grey with vinyl transition strips where the carpet abuts the terrazzo. The carpet is turned up at the wall base approximately four inches over the terrazzo base. The top of the carpet that is turned up at the wall is sealed with a sealant material that is different in color from the carpet. The nosings of the stair treads have been painted with slip-resistant grey paint by JNEM staff. The coating is applied annually, according to JNEM maintenance personnel (Figure 87).

Figure 87. Slip-resistant paint applied to nosing of terrazzo stairs. Source: BVH, 2008

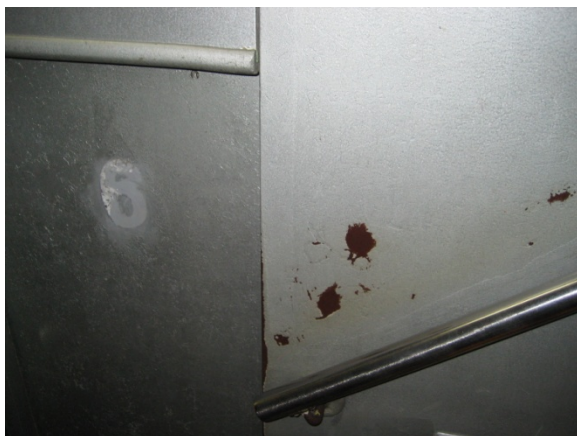
Figure 88. Example of worn paint surfaces, tram load zone. Source: BVH, 2008

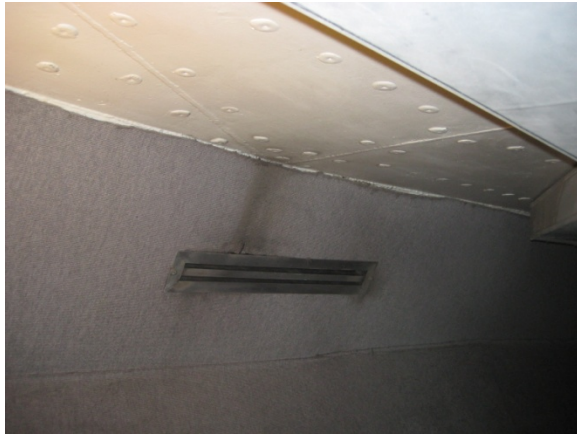
Figure 89. Wall carpet applied to outer steel skin at upper tram load zone. Note soot stain at supply register. Source: BVH, 2008

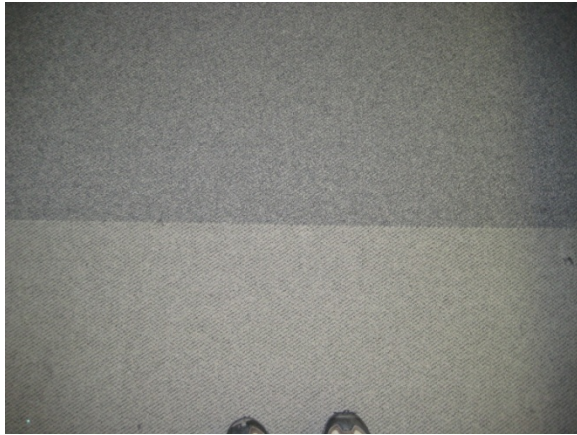
The floor of the observation level is composed of removable 1/4 inch abrasive steel plate. The floor of the observation level is carpeted with the same carpet that is found on the walls. The carpet is in fair condition. Replacement of sections of the floor carpet is evident, with carpet sections from differing dye lots used (Figure 96). The floor surface follows the curve of the Arch. An access hatch, located at the centerline of the Arch, provides access to the tram electrical equipment housed in the interstitial space below the observation floor. The hatch is covered with the same carpeting as used on the rest of the floor surface (Figure 97).

Figure 96. Floor carpet located at the observation level. Note color variation of carpet. Source: BVH, 2008

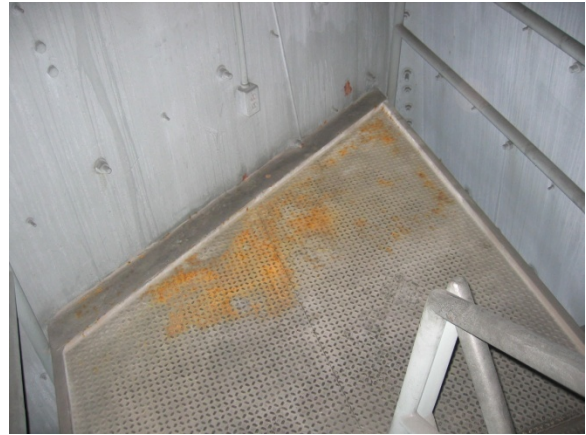
specified to be factory primed with red lead primer and painted with a field applied grey top coat. The legs of the Arch are essentially a large void space with a series of spiral stairs and switch-back stairs and landings composed of 1/4 inch “checkerplate” with medium pattern. The stairs and landings are in fair condition, with corrosion on some stairs and landings (Figure 103). Handrails are 2 inch outside diameter steel pipe primed and painted, with a grey topcoat. The handrails are in good condition. Various sections of the stairs are enclosed with fencing material composed of 2x2 welded wire fabric (Figure 104). Refer to the Structural section, below, for a discussion of the exposed interior structure of the Arch.

Figure 103. Corrosion on checkerplate landing, interior of Arch leg. Source: BVH, 2008

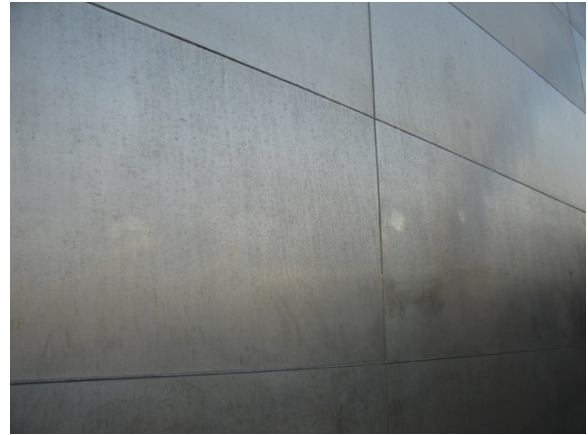
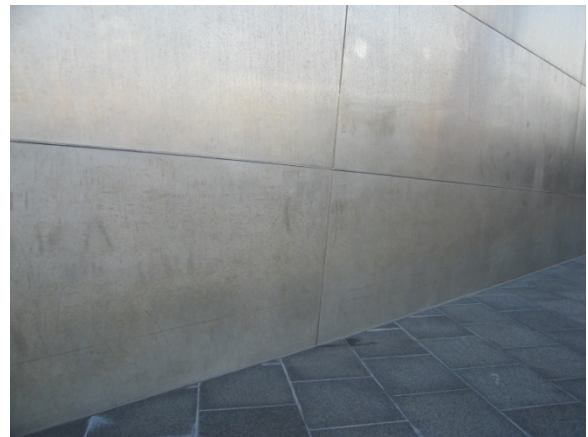
As completed the field welds are not as neatly done as the shop welds. Oftentimes the field welds were completed as multi-pass welds in order to accommodate tolerances between the triangular tubular sections. The field welds on the exterior are multi-pass full penetration groove welds, with the reinforcement above the plate not ground smooth. The multi-pass welds vary in size as necessary to accommodate dimensional variances. Some of the horizontal field welds between successive sections appear to be discolored, which is most likely attributed to atmospheric soiling (Figures 108 and 109). Mr. Kolkmeier indicated that the field welds at the stainless steel plates on the exterior were not ground flush as an architectural decision, and helped establish the pattern on the skin of the Arch that was desired by Saarinen.¹¹² The locations of the plug welds where the creeper derricks were attached were ground flush and are thus undetectable from grade.

Figure 108. View showing discoloration of field welds near the base of the Arch. Source: WJE, 2008.

Figure 109. View showing discoloration of field welds near the base of the Arch. Source: WJE, 2008.

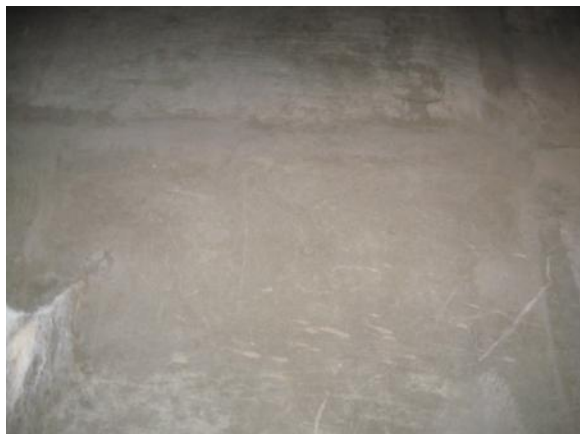
Minor cracking exists at isolated locations throughout the concrete foundation walls of both the north and south legs (Figures 127 and 128).

Figure 128. View of minor shrinkage cracks at the concrete footings. Source: WJE, 2008.

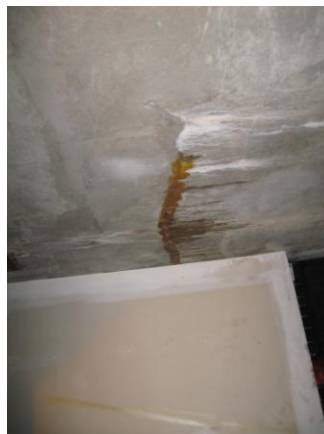
Isolated locations of the concrete ceiling, visible in the tram load zone only, exhibit spalling and exposed staining caused by corrosion of the reinforcing bars (Figure 131).

Figure 131. View of corrosion stains and white staining indicative of moisture infiltration. Source: WJE, 2008.

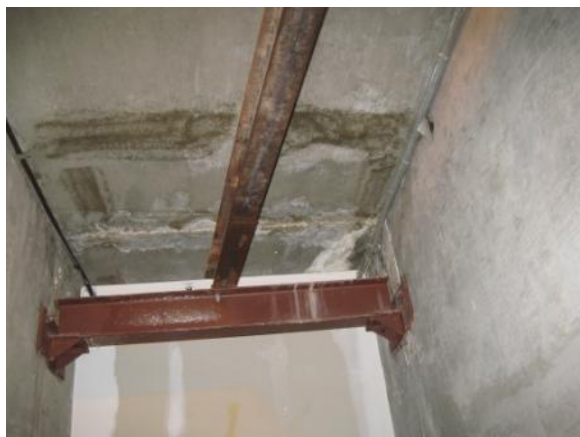
At some of the hairline cracks white efflorescence staining was observed leaching from the cracks, which usually is an indication of moisture migrating through the concrete (Figure 129).

Figure 129. View of shrinkage cracks and moisture infiltration at concrete footings. Source: WJE, 2008.

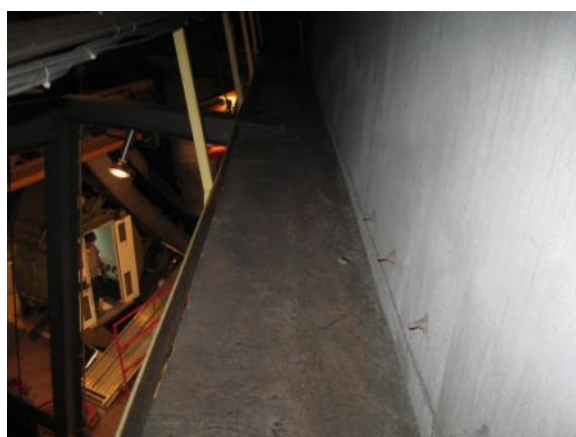
Surface corrosion was present on the steel plates at the transition from the steel triangular cross section to the concrete foundation walls (Figure 132).

Figure 132. View of minor surface corrosion at the transition plate between the interior steel skin and the concrete foundation walls. Source: WJE, 2008.

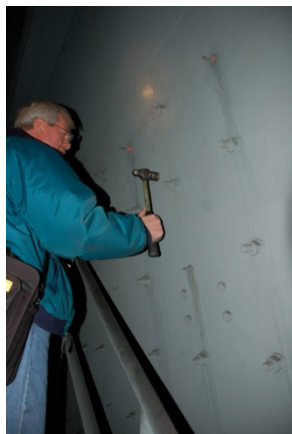
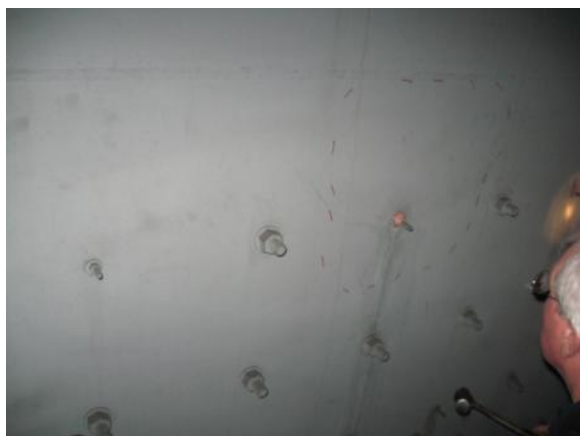
Sounding was performed on the surface of the interior plate at the locations where corroding fastener heads were found. At these locations, delamination (an air gap) exists between the concrete and the interior skin. The hollow sounding areas were primarily concentrated at the corroding fasteners and along the length of the stiffener angles, where it was presumably difficult to consolidate the concrete around these elements (Figures 133 and 134). Refer to drawing S107-B in Appendix I.

Figure 133. The interior carbon steel skin was sounded to identify delaminations. Source: WJE, 2008.

Figure 134. Delamination identified in interior carbon steel skin by sounding, highlighted by dotted lines. Source: WJE, 2008.

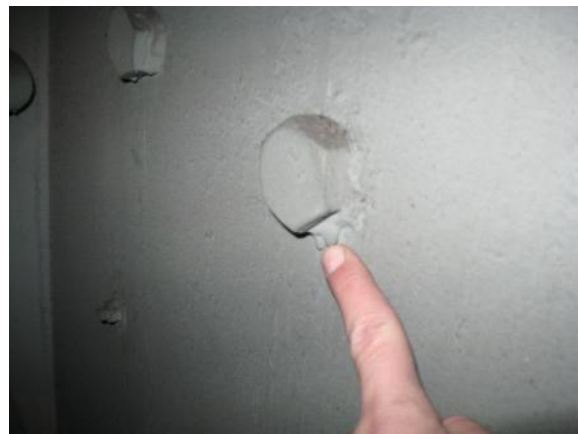
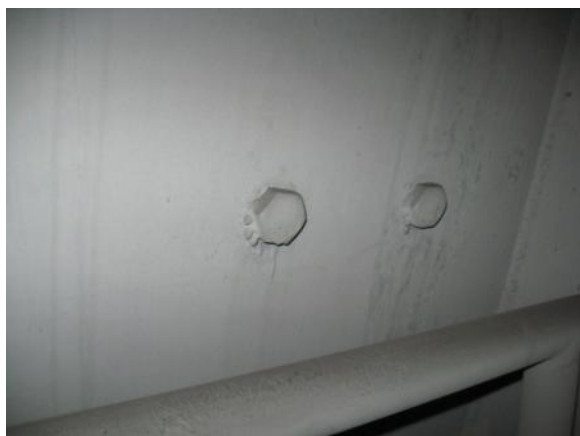
At isolated fastener heads remaining from the erection framing below Segment 45, which marks the top of the concrete pour, cement paste has leached out at some of the bolt heads (Figures 135 and 136).

Figure 136. View of cement paste leaching out at bolt heads. Source: WJE, 2008.

Figure 135. View of cement paste leaching out at bolt heads. Source: WJE, 2008.

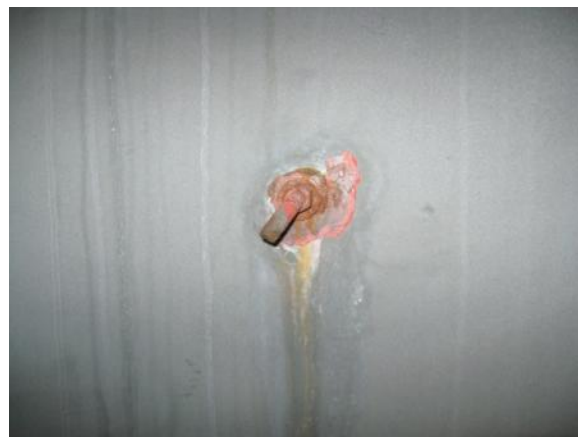
Figure 137. View of bent and deformed shanks of the tie rod bolts. Source: WJE, 2008.

At isolated locations, some of the shanks of the stud bolts connecting the diagonal tie rods to the vertical stiffener angles are bent and deformed, as shown in Figure 137. Variable extensions exist at the 3/8 diameter stud bolts, fastening the diagonal tie rods and the vertical stiffener angles together, as shown in Figure 138. The bolt sizing and placement below Station 46 at the concrete transition varies (Figures 139 and 140). The bolts are 3/8 inch diameter stud mild steel and high-tension steel, with 2 by 3/8 inch straps below Station 45. The typical bolt layout away from the corners is shown in Figure 141. Also refer to drawings S107 and S107-B in Appendix I. The transition layout for the bolts between Stations 45 and 46 includes 7/8 inch diameter high-tension stud bolts and 1-1/2 inch diameter bolts at the corners, with tighter spacing (Figures 142 and 143). Also refer to drawing S108 in Appendix I.

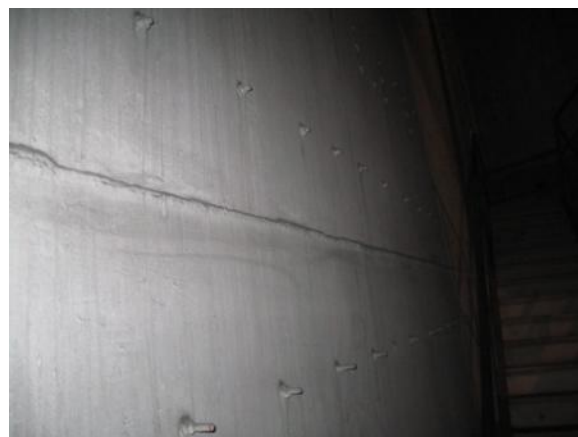
Figure 138. View of variable extensions at the 3/8 diameter stud bolts. Source: WJE, 2008.

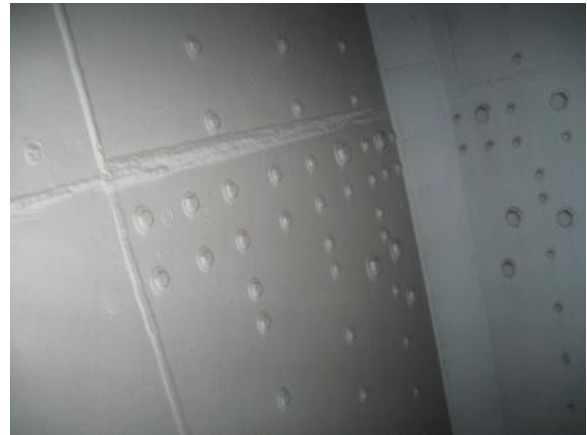
Figure 146. View of variable field welds. Source: WJE, 2008.

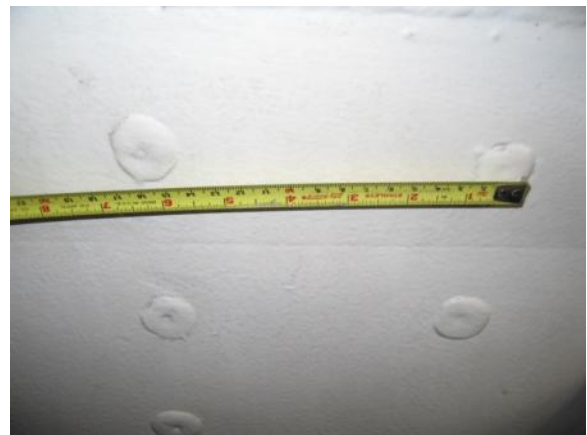
Figure 147. View of plug welds from Station 0 to 28. Source: WJE, 2008.

From Station 0 to Station 28, the interior 1/4 thick stiffener plates, diaphragms, and 1/2 inch diameter diagonal bars are plug welded to the interior skin plate with 3/4 inch plug welds spaced at approximately 6 inches on center (Figures 147 and 148). The thicker interior skin corner plates (1-3/4 inch thick) are bolted to the interior stiffener plates with 1/2 diameter high strength bolts. The exterior skin plates are fastened to the internal stiffener plates and diaphragms with double spot fillet welds, spaced at a maximum of 5 inches on center. Transverse plates approximately 3/8 inches thick are welded to the inside face of the exterior plate and a closure plate at the interior skin, at each station line.
